COMPREHENSIVE MOTOR VEHICLE SERVICES & CONSULTING Motor Vehicle Forensic Analysis Report

People of the State of New York v.
Nauman Hussain

REFERENCED INVOLVED SUBJECT VEHICLE: 2001 Ford Excursion Stretch Limousine,
VIN 1FMNU40S51EB10299

MOTOR VEHICLE AUTOPSY FORENSIC INVESTIGATION SUMMARY

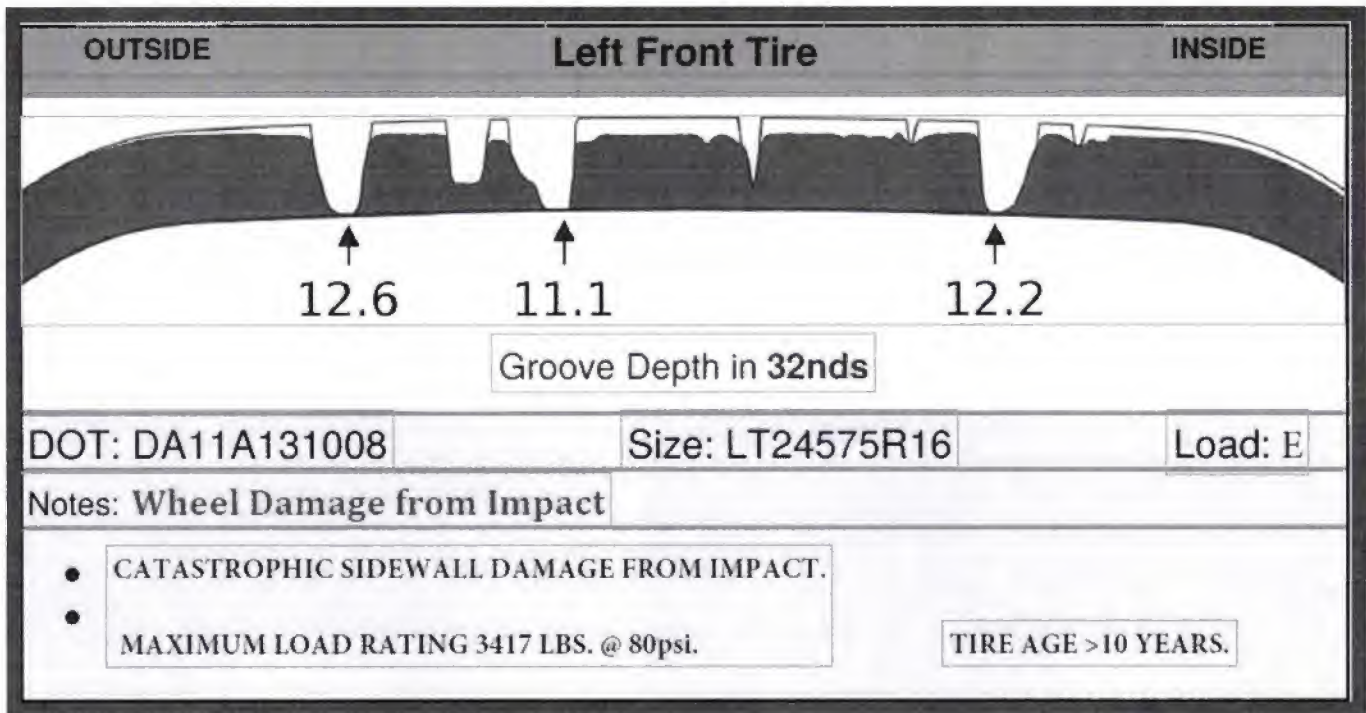
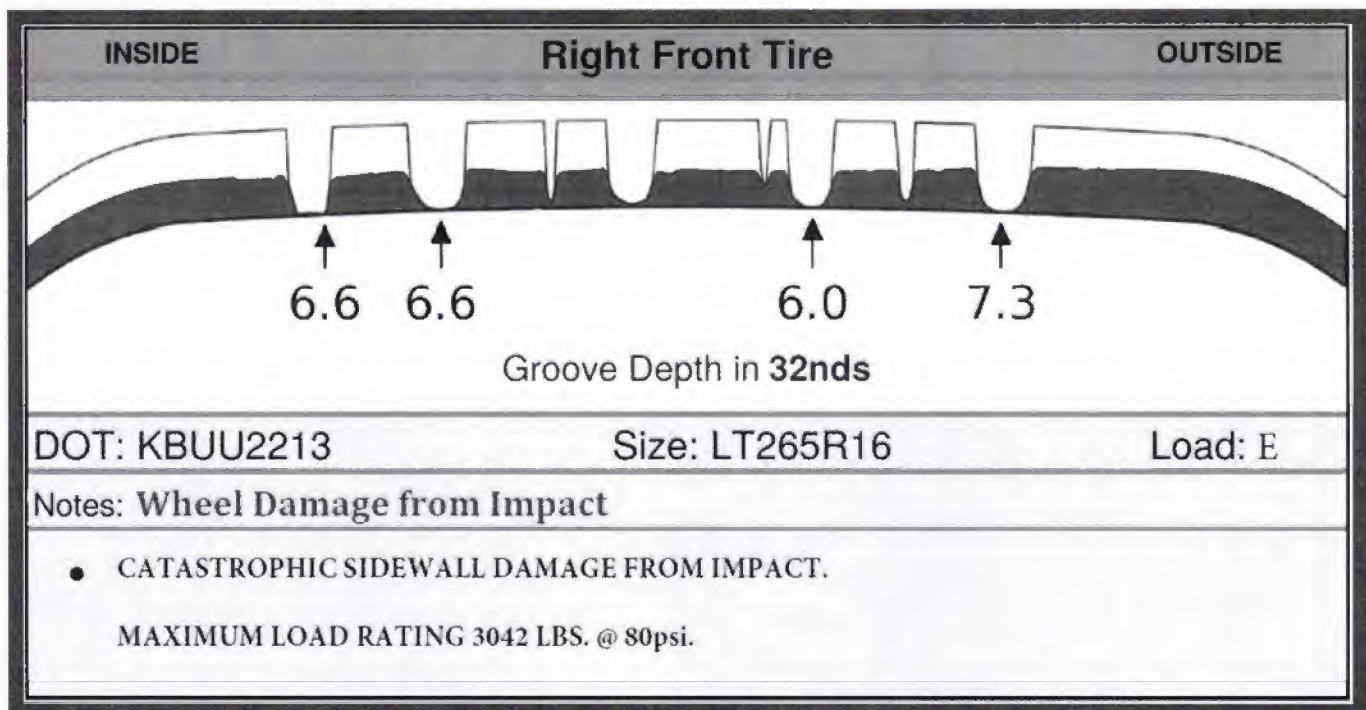
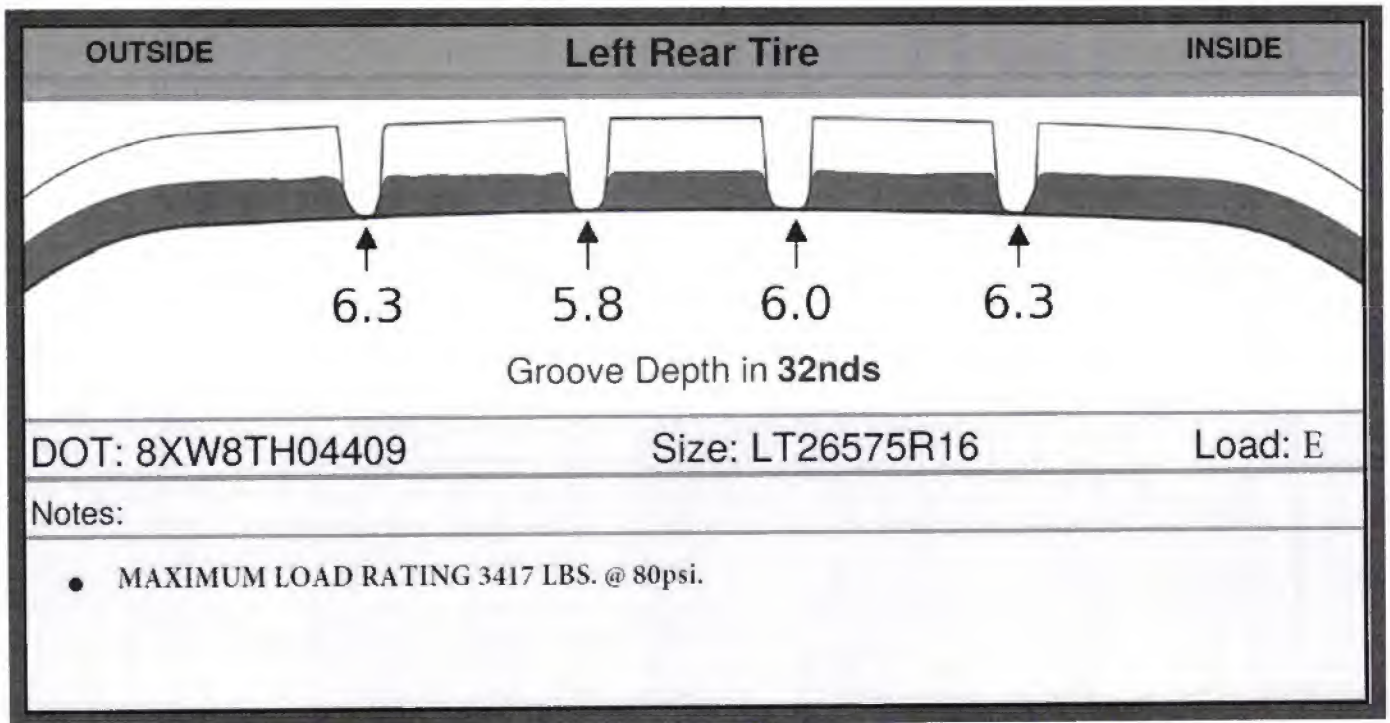
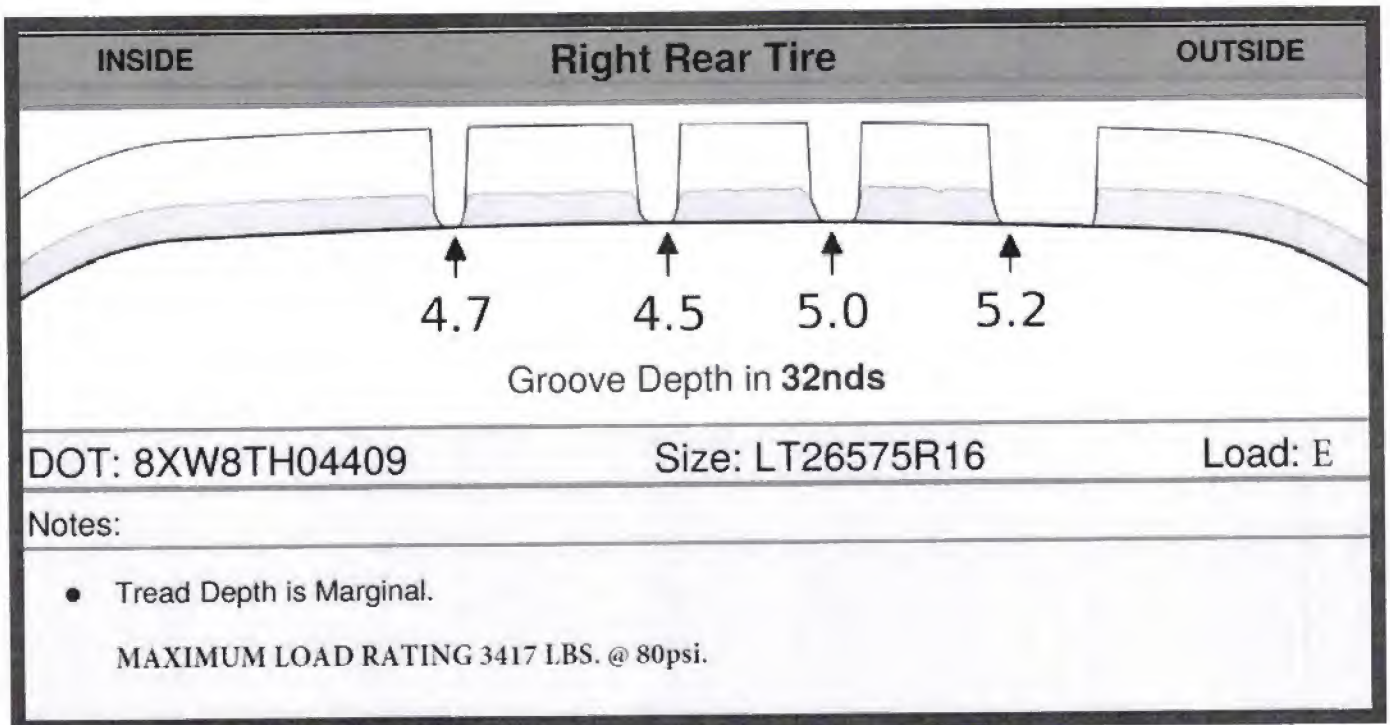
The inspection of the four tires and wheels of the 2001 Ford Excursion stretch limousine in this case revealed no evidence of pre-crash failure conditions. Tire tread depth, performed with specialized laser equipment, was sufficient at all locations. However, the wheel installed at the left front of the vehicle was that of steel design, as opposed to the original manufacture alloy composition wheels located at the remaining three locations on the vehicle. Additionally, the tire installed at the left front of the vehicle was that of a size of LT245/75R16, while the tire size at the remaining three locations was that of LT265/75R16 -- the original manufacturer tire size.

The results of the specialized tire scan laser equipment, along with tire notations, are provided on the next two pages of this expert report.

Summary of Analysis, Tires/Wheels of the Vehicle: *The examination and analyses of the tire/wheel components of the 2001 Ford Excursion stretch limousine in this case revealed that although tire failure was not a causal aspect of this multiple fatality crash, the following deficiencies existed during the pre-crash operation of the vehicle:*

This mismatch condition results in the imbalance of unsprung weight, left to right front.

This mismatch condition of tire sizes can result in steering pull during operation and braking.

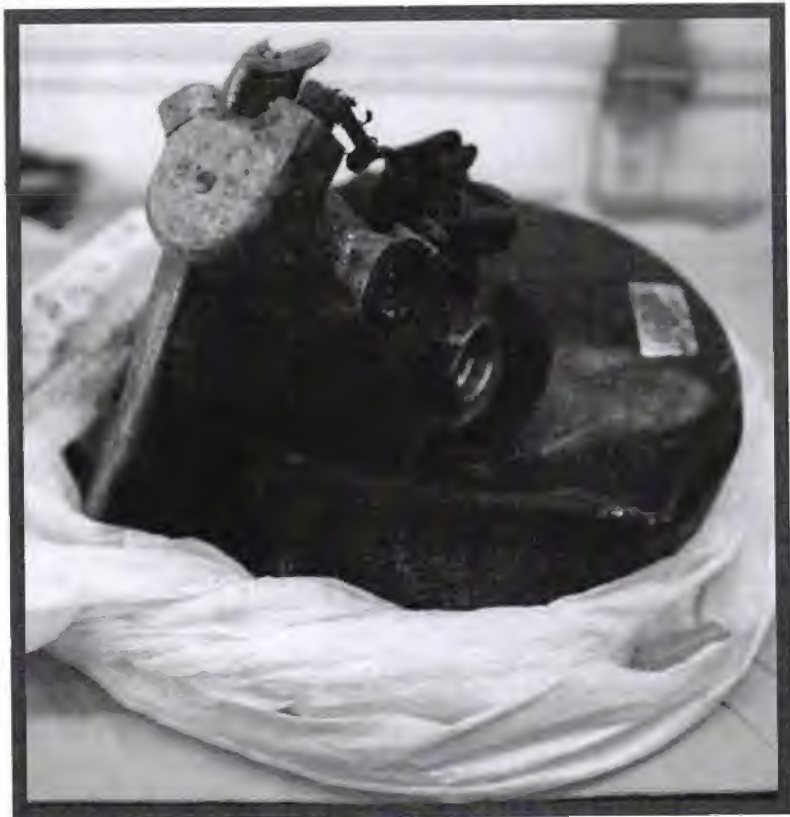
Image No.40. This photograph depicts the brake master cylinder and the power brake vacuum booster of the 2001 Ford Excursion stretch limousine during the period of individual component analysis. The severity of crash impact resulted in 1) separation of the brake master cylinder reservoir; 2) deformation of the front and rear steel brake tubing; and 3) deformation of the power brake vacuum booster housing.
